## City of Alexandria Storm Sewer Capacity Analysis (CASSCA)

### Cameron Run Condition Assessment

**PREPARED BY:** Michael Baker Jr., Inc.

**DATE:** November 4, 2014 (Revised May 26, 2015)

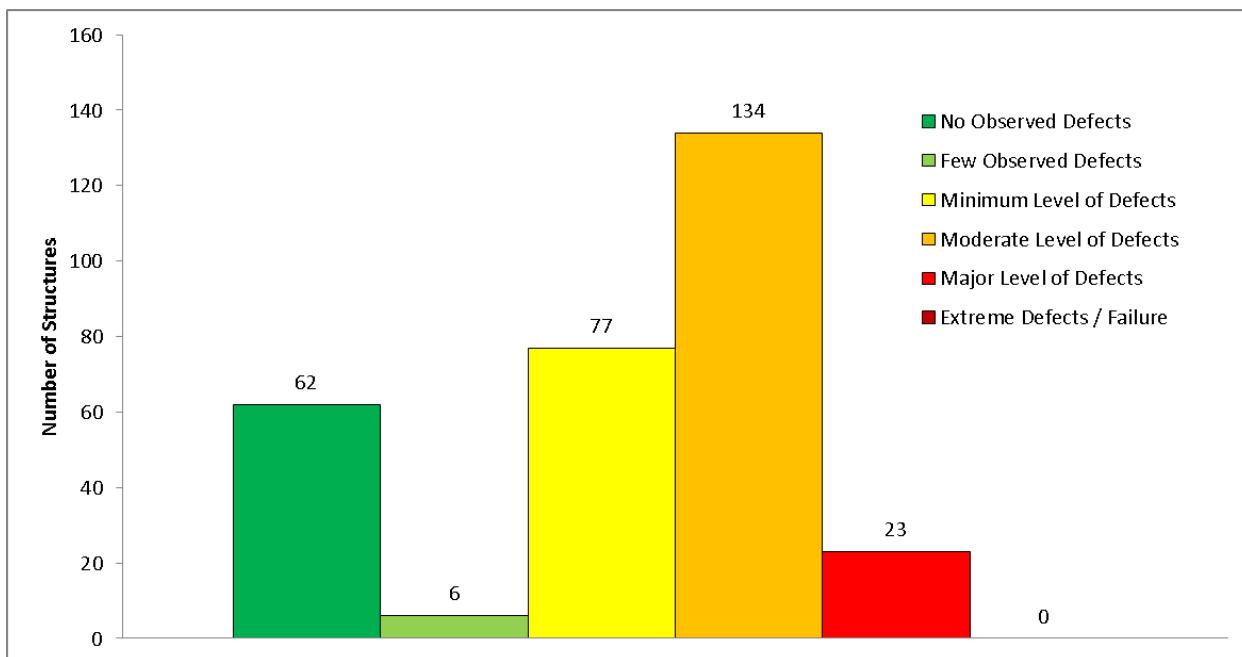
As part of this inspection task, 302 storm structures were inspected in the Cameron Run watershed. Figure 1 shows the number of structures within each defect category identified in the previous section. Figure 2 shows the geographic location of each structure within the Cameron Run watershed, color coded to its defect category. The average condition score of the storm structures was 37 (Minimum defect category). The largest defect group was the major category (scores 61-80), with about eight (8) percent of the structures. About 48 percent of Cameron Run structures ranked in the minimum, few defect categories or lower (scores 0-40). Approximately 44 percent of the Cameron Run structures were rated 41-60 (Moderate). None of the inspected Cameron Run structures were ranked in the extreme category. The highest structure score was 72.

**Figure 1. Structure Inspections Summary.**

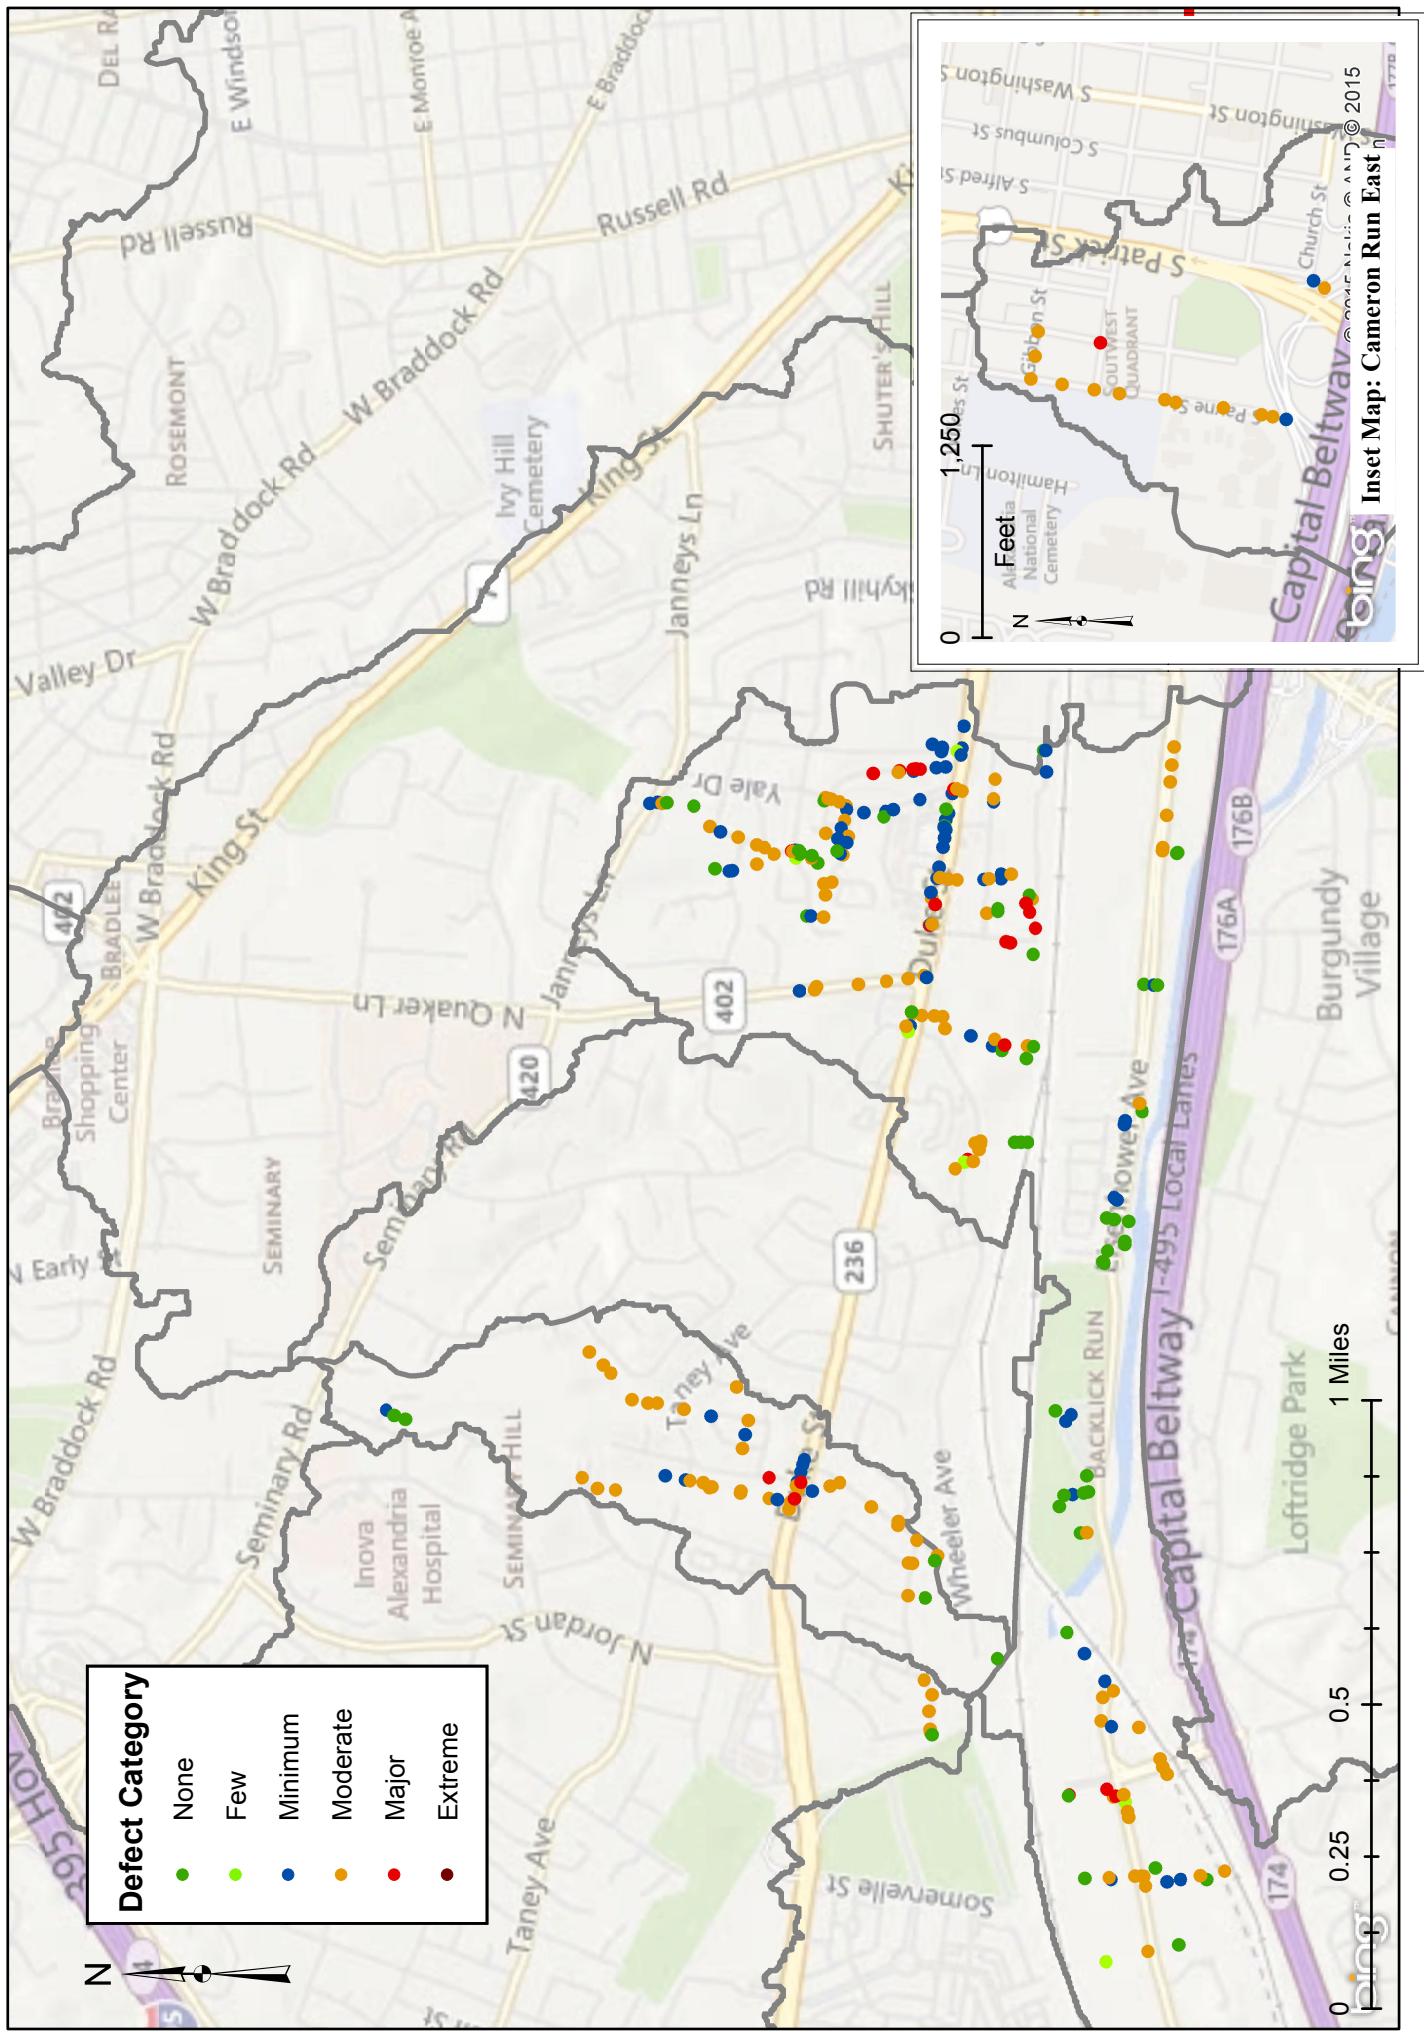
**Figure 2. Overall Condition of Storm Structures (Color coded by Severity of Defects).**

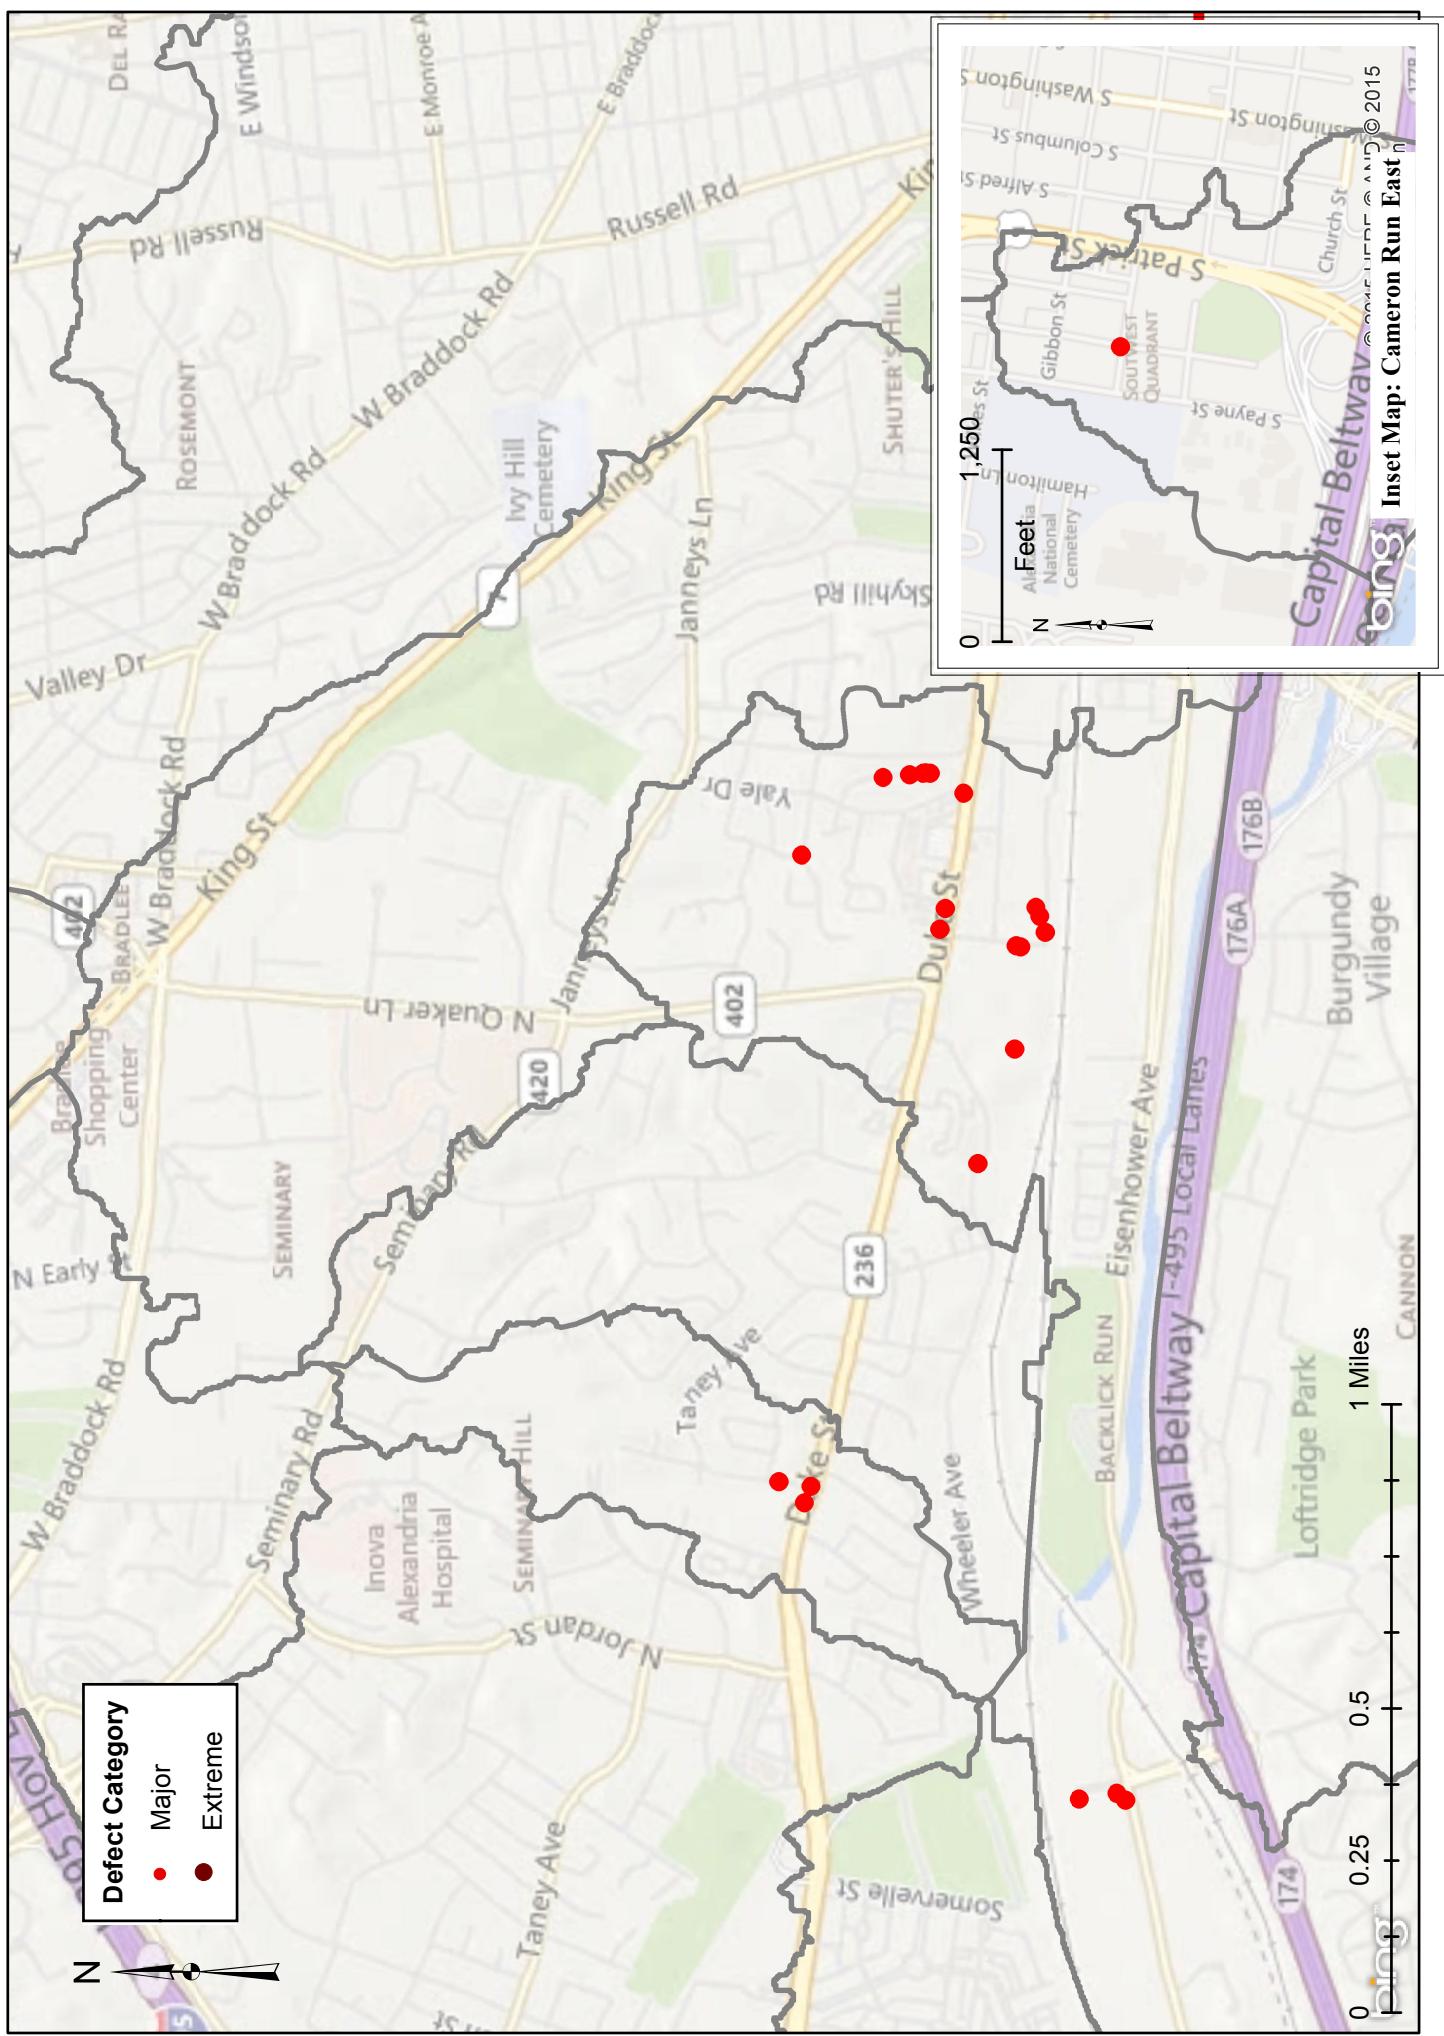
Figure 3 displays the location of the structures classified with major damage only. Extreme damage was not observed within the Cameron Run watershed. Most structures with high defect scores are observed along Duke Street in the center subwatershed of the Cameron Run watershed. For further detailed condition assessment, the inspection results of the structures were broken down by structure component. Table 2 lists the number of observed defects by component and severity. Note that the table shows a count of the number of defects found in each component and their respective severity across all structures, not the number of inspections performed. Multiple defects may be found in a single component of a structure.

**Figure 3. Location of Storm Structures in the "Major" and "Extreme" Categories (Color coded by Severity of Defects).**

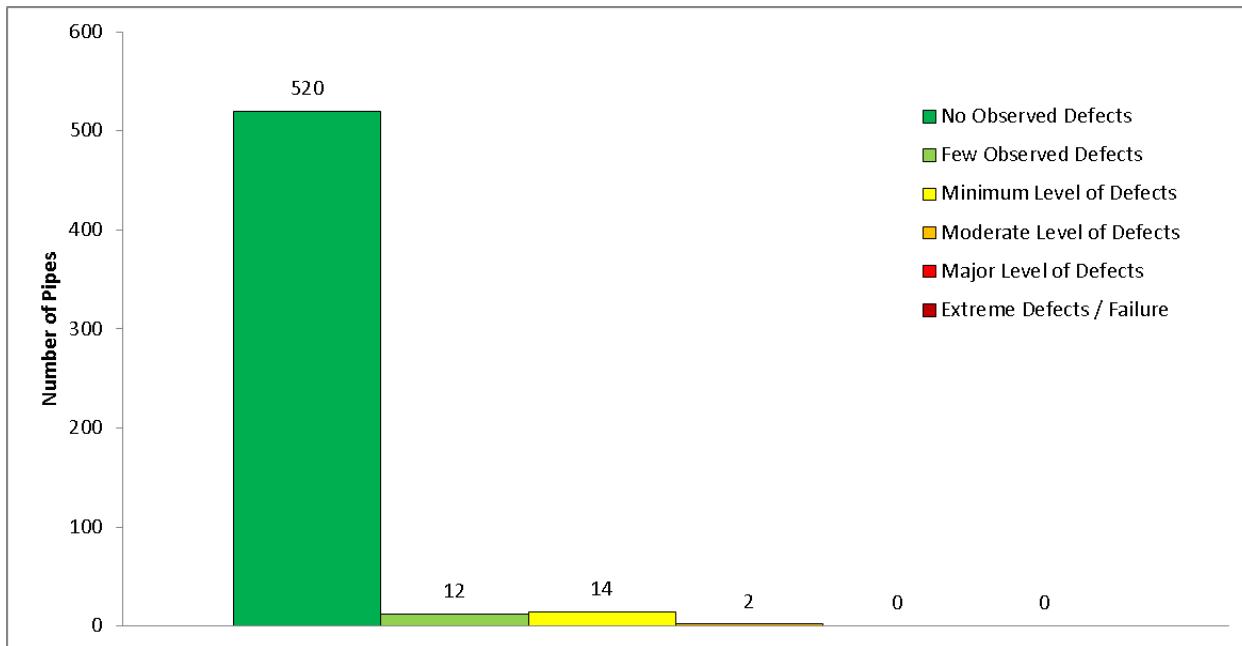
In total, 548 storm sewer pipe segments were inspected in the Cameron Run watershed. Figure 11 shows the number of pipe segments within each defect category. Figure 12 shows a map of the location of each inspected pipeline, color coded by the defect categories identified previously in the memorandum. The average condition score of the storm pipe segments inspected within the Cameron Run watershed was 1.3 (few). Inspection results in Cameron Run showed that the pipe segments were observed to be in generally good condition, with no defect observed in 95% of the pipes.

Figure 11. Pipe Lamping Inspections Summary.

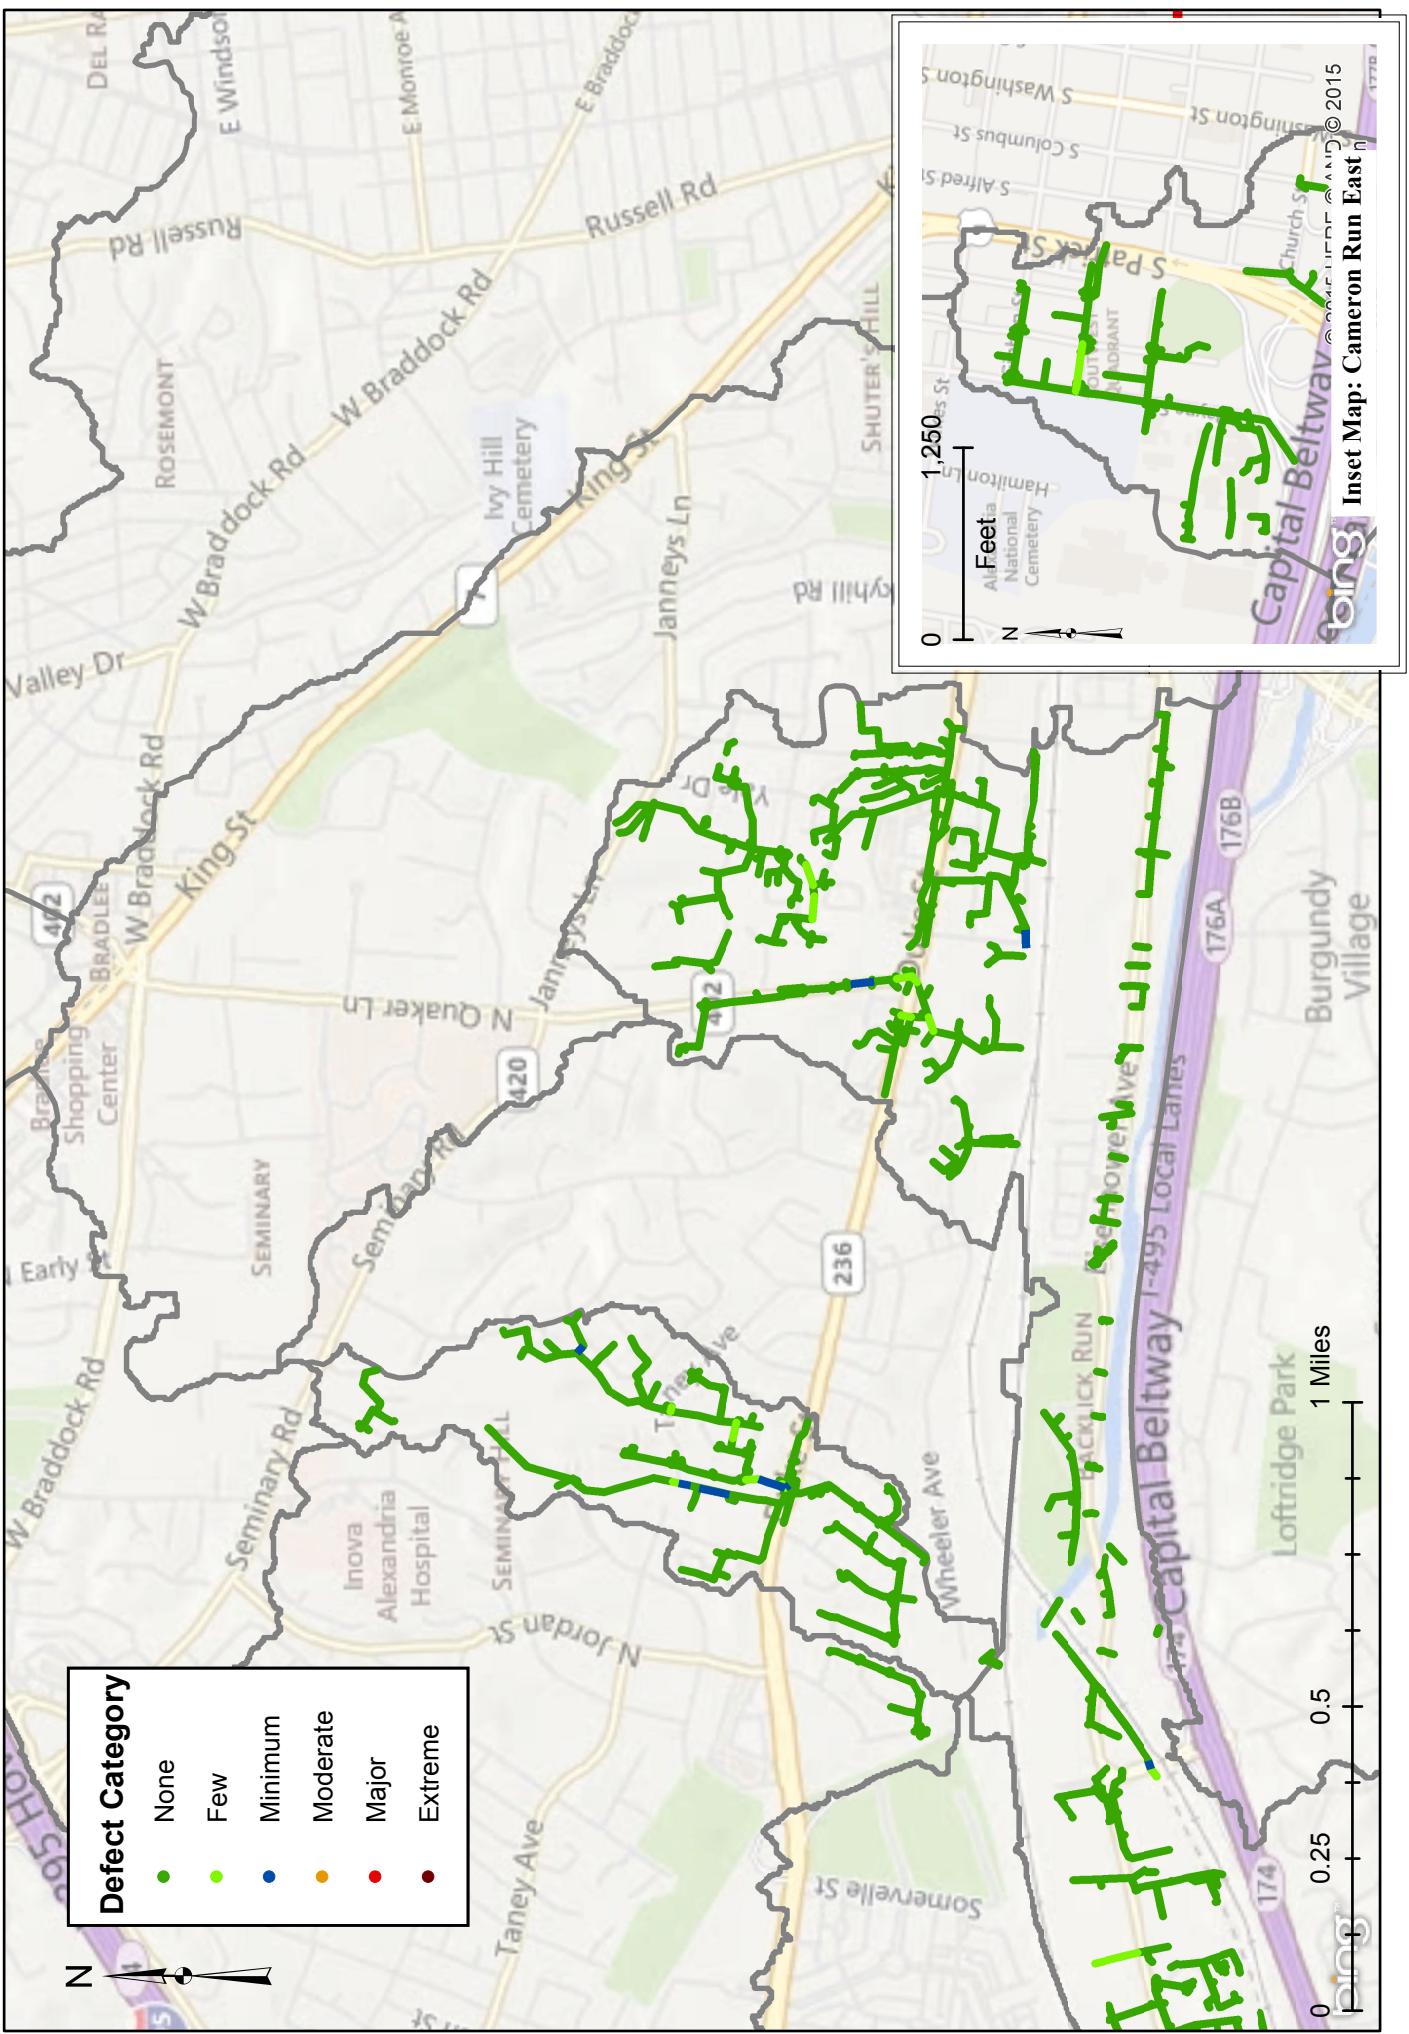
Figure 12. Overall Condition of Storm Pipelines (Color coded by Severity of Defects).
